TEST HOLE INVENTORY  
PROJECT: SW 48TH AVENUE COMPLETE ST - THS  
PROJECT NO.: PF22075  
PROJECT MANAGER: ANDRES GARCIA  
CLIENT: CRAVEN THOMPSON & ASSOCIATES  
DATE: 1/17/23

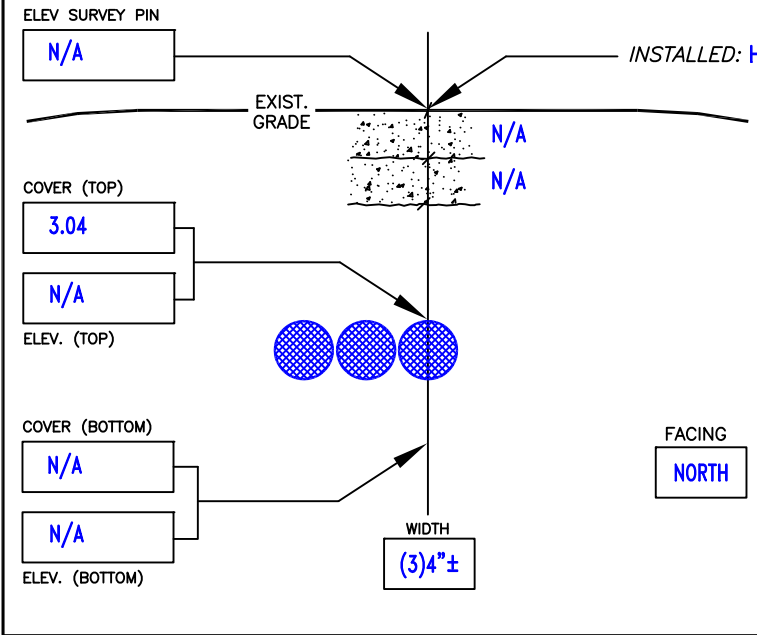
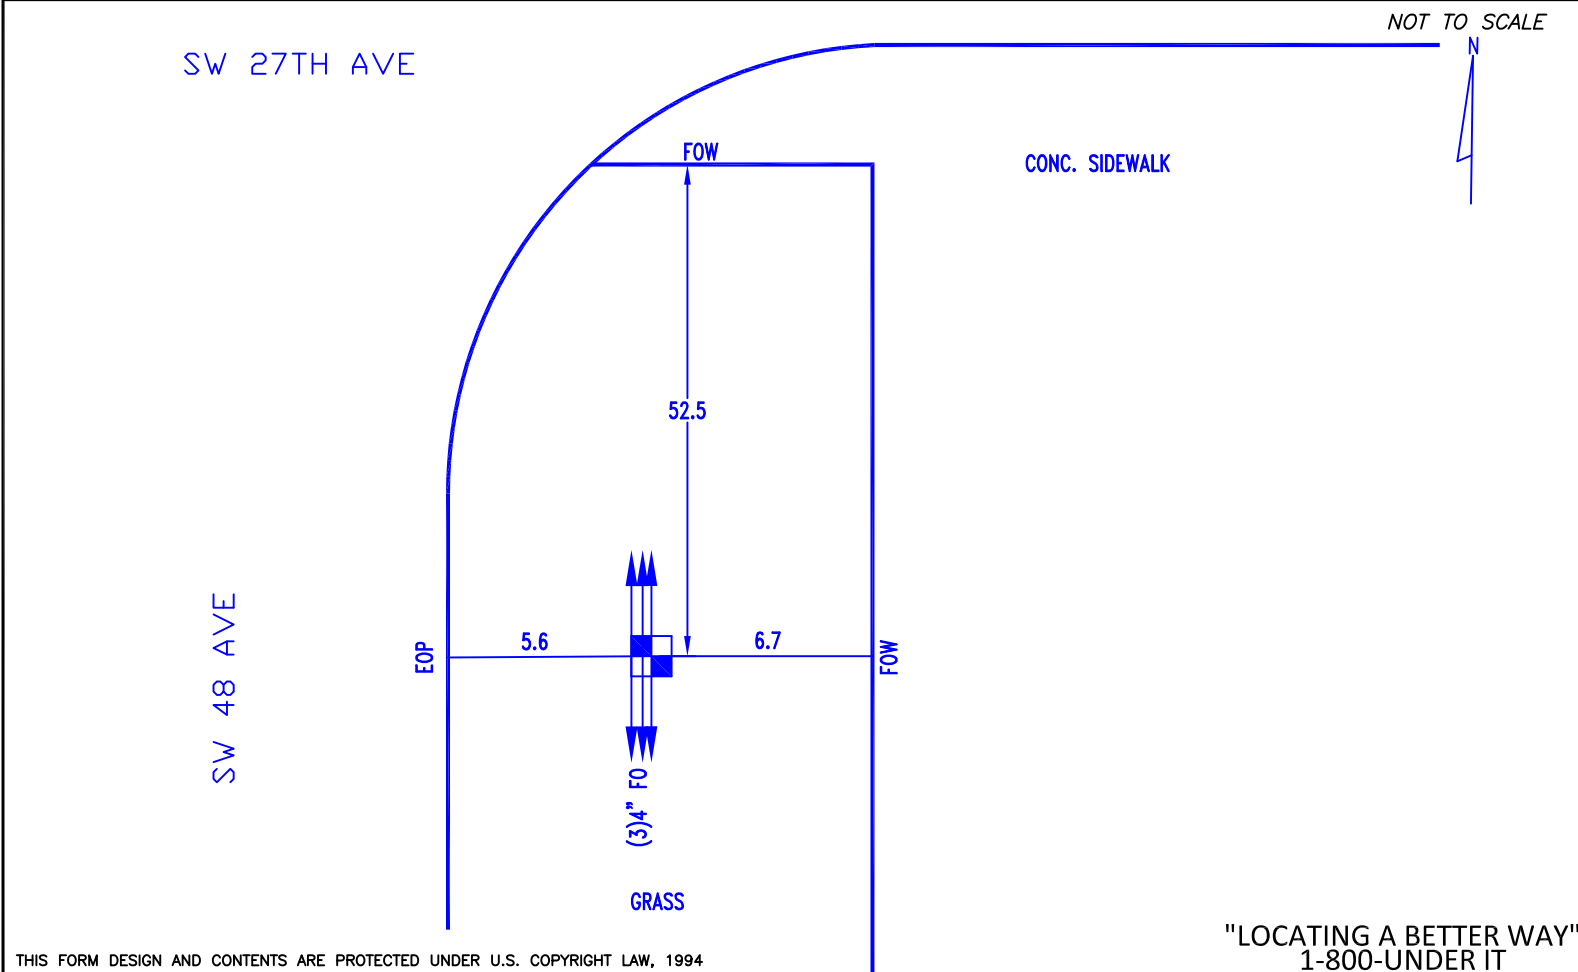
PROJECT NAME:	SW 48TH AVENUE COMPLETE ST - THS
LOCATE REQUESTED BY:	CRAVEN THOMPSON & ASSOCIATES
UTILITY REQUESTED:	FIBER OPTIC
UTILITY FOUND:	FIBER OPTIC
MATERIAL AS FOUND:	PVC(BLACK)
SIZE AS FOUND:	(3)4"

CLIENT JOB#	N/A	WORK ORDER #	N/A		
PROJECT LOCATION:	WEST PARK, FL				
SHEET #:	C-19 OF N/A	PROPOSED:	UTILITY WORK		
FORM BY:	MP	ASSISTED BY:	DC	# OF HOLES:	1
PAVING CONDITION:	N/A	DATE DUG:	1-5-23		
SOIL CONDITIONS:	HARD DRY SAND ROCKY				
UTILITY CONDITION:	FAIR

NOTES: TEST HOLE REVEALED (3)4" PVC(BLACK) CONDUITS. HUB AND TACK SET ON EASTERN MOST UTILITY. OFFSET 1.54' FROM HUB.

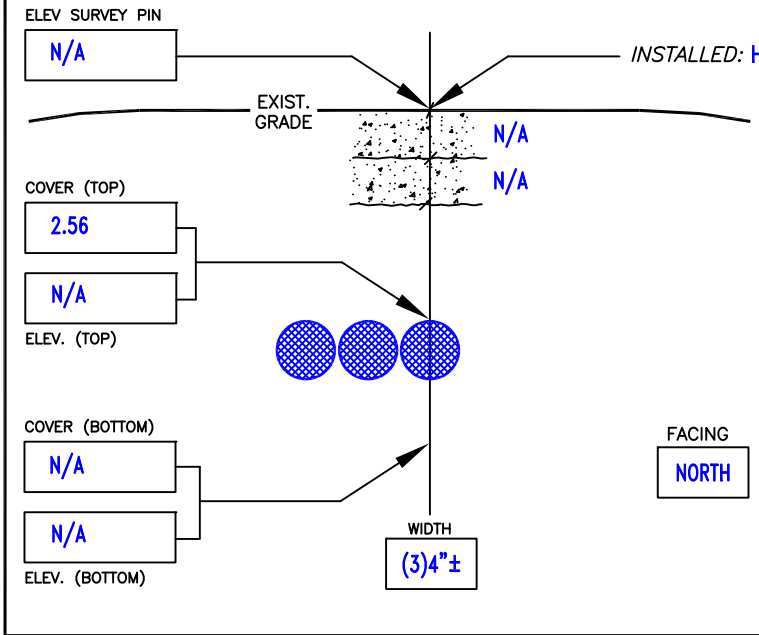
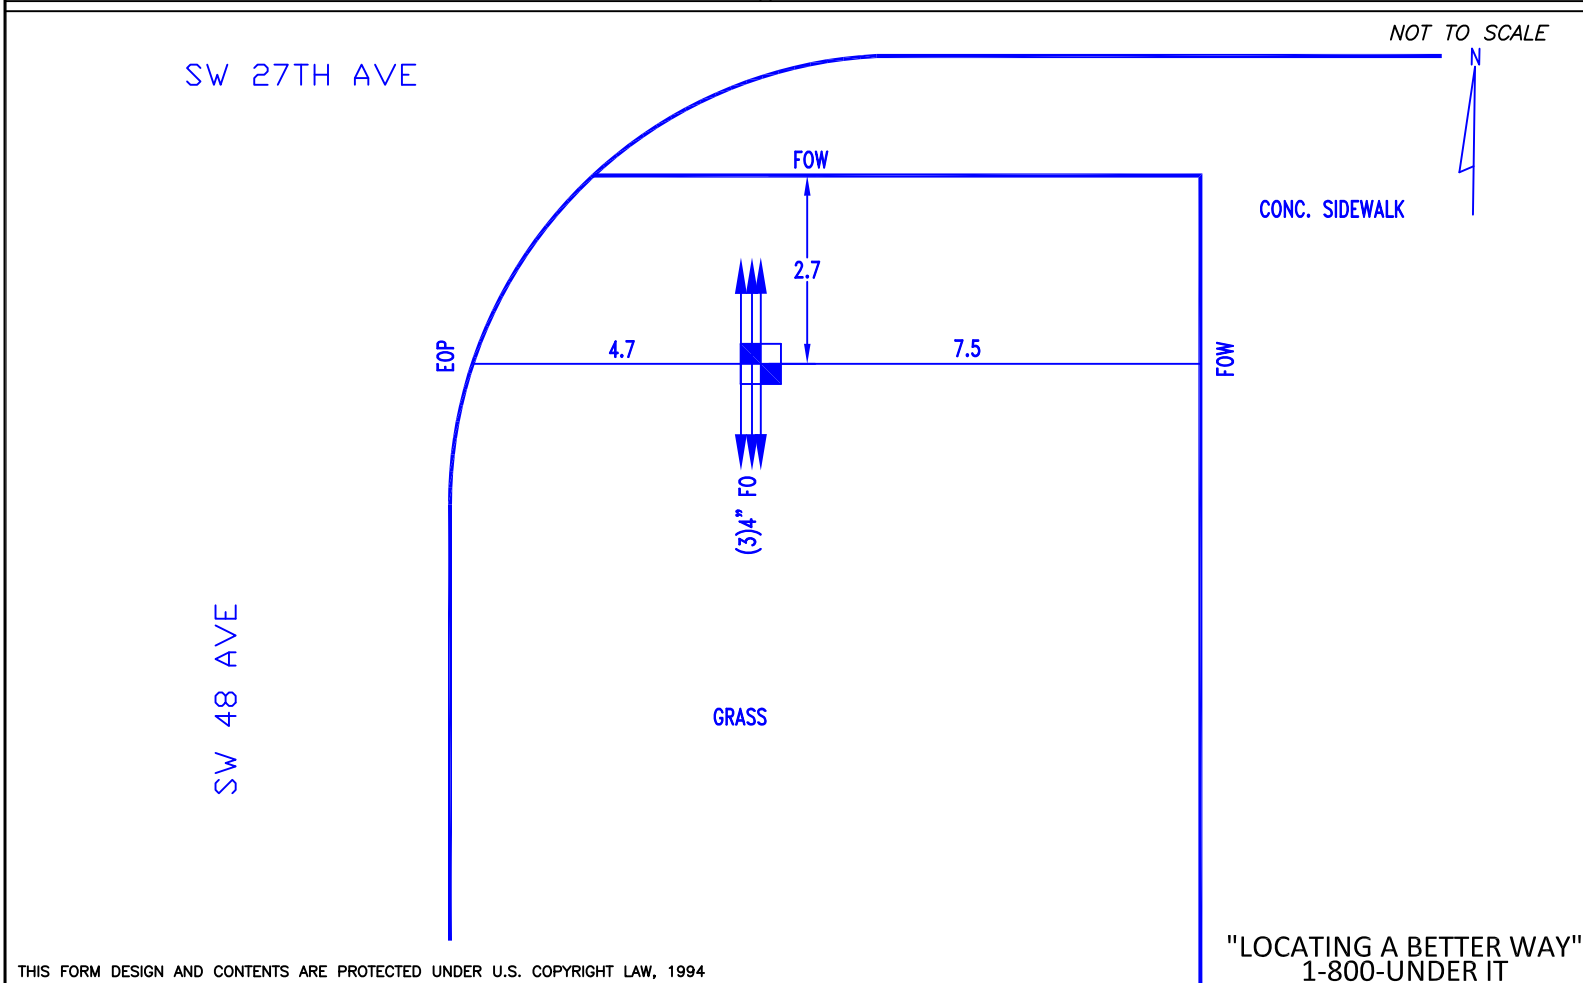
PROJECT NAME:	SW 48TH AVENUE COMPLETE ST - THS
LOCATE REQUESTED BY:	CRAVEN THOMPSON & ASSOCIATES
UTILITY REQUESTED:	FIBER OPTIC
UTILITY FOUND:	FIBER OPTIC
MATERIAL AS FOUND:	PVC(BLACK)
SIZE AS FOUND:	(3)4"

CLIENT JOB#	N/A	WORK ORDER #	N/A		
PROJECT LOCATION:	WEST PARK, FL				
SHEET #:	C-19 OF N/A	PROPOSED:	UTILITY WORK		
FORM BY:	MP	ASSISTED BY:	DC	# OF HOLES:	1
PAVING CONDITION:	N/A	DATE DUG:	1-5-23		
SOIL CONDITIONS:	HARD DRY SAND ROCKY				
UTILITY CONDITION:	GOOD

NOTES: TEST HOLE REVEALED (3)4" PVC(BLACK) CONDUITS. HUB AND TACK SET ON EASTERN MOST UTILITY. OFFSET 1.54' FROM HUB.

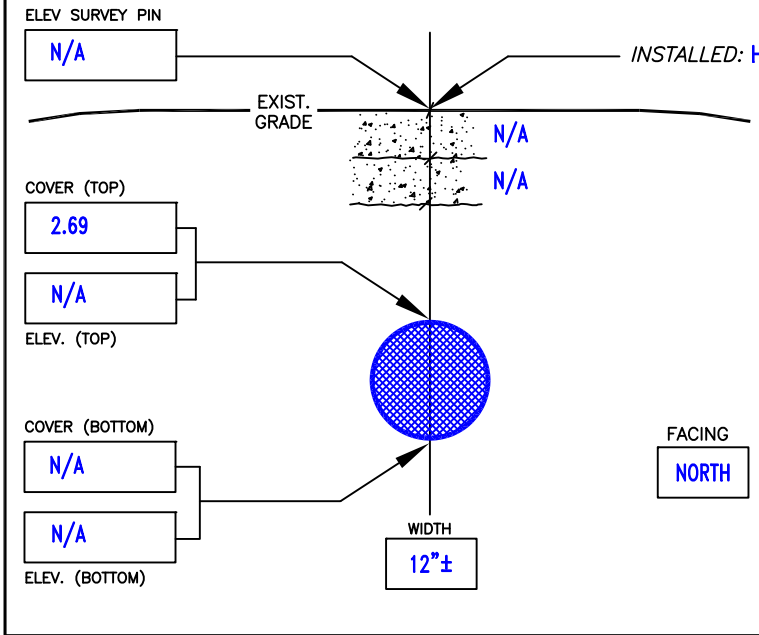
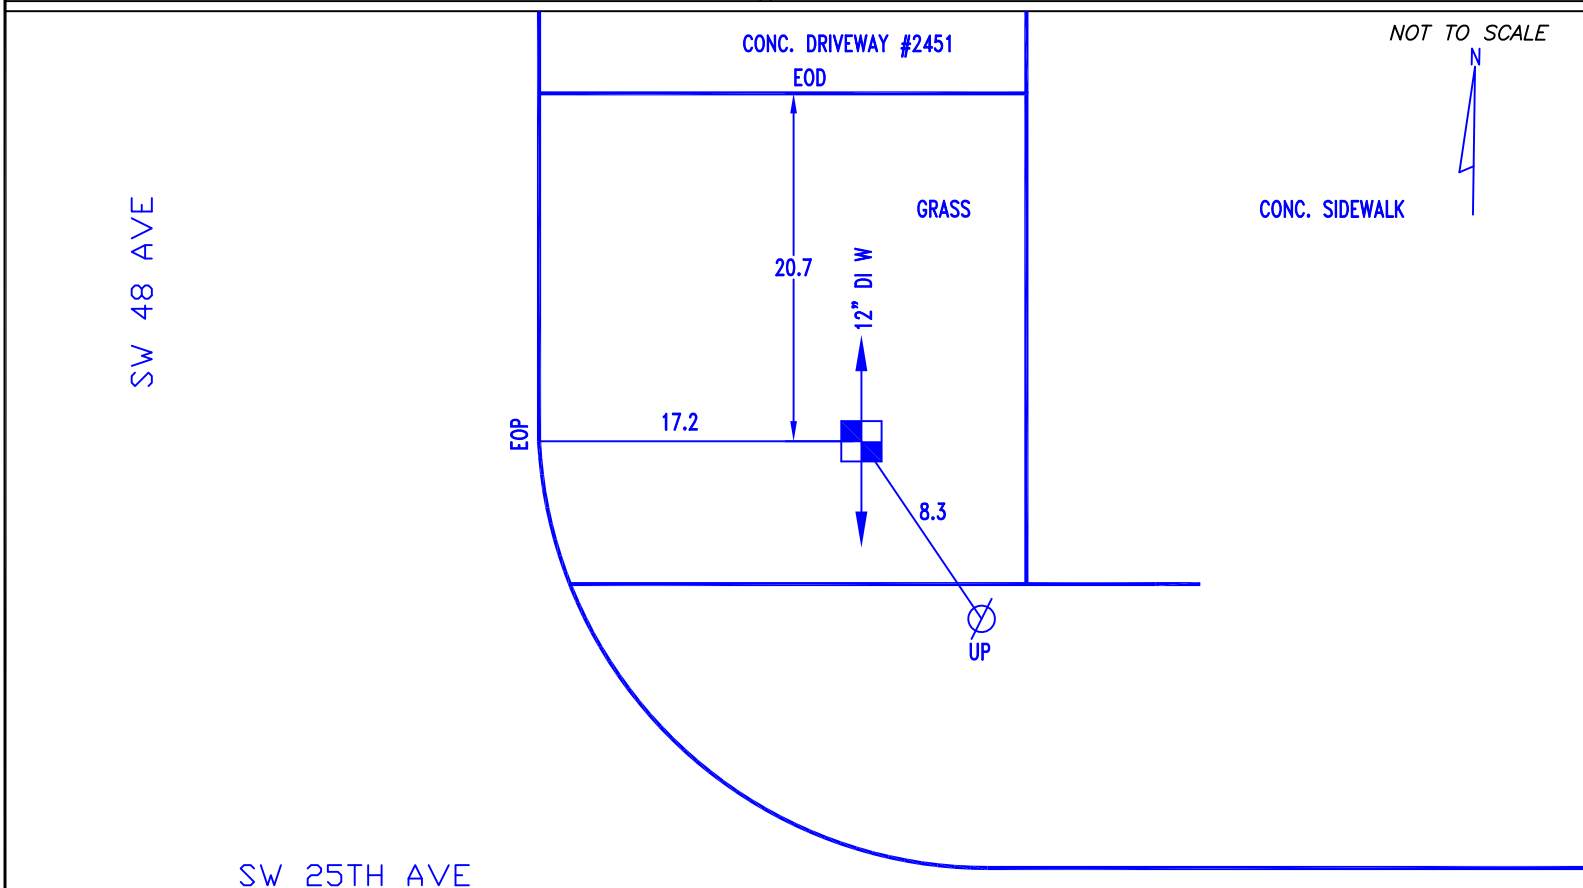
PROJECT NAME:	SW 48TH AVENUE COMPLETE ST - THS
LOCATE REQUESTED BY:	CRAVEN THOMPSON & ASSOCIATES
UTILITY REQUESTED:	WATER
UTILITY FOUND:	WATER
MATERIAL AS FOUND:	DUCTILE IRON
SIZE AS FOUND:	12"

CLIENT JOB#	N/A	WORK ORDER #	N/A		
PROJECT LOCATION:	WEST PARK, FL				
SHEET #:	C-21 OF N/A	PROPOSED:	UTILITY WORK		
FORM BY:	MP	ASSISTED BY:	DC	# OF HOLES:	1
PAVING CONDITION:	N/A	DATE DUG:	1-5-23		
SOIL CONDITIONS:	HARD DRY SAND ROCKY				
UTILITY CONDITION:	GOOD

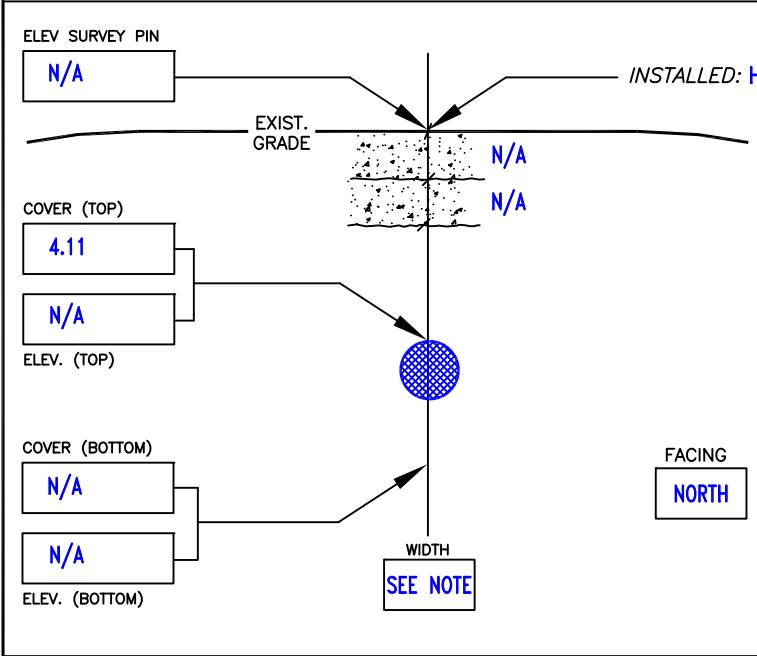
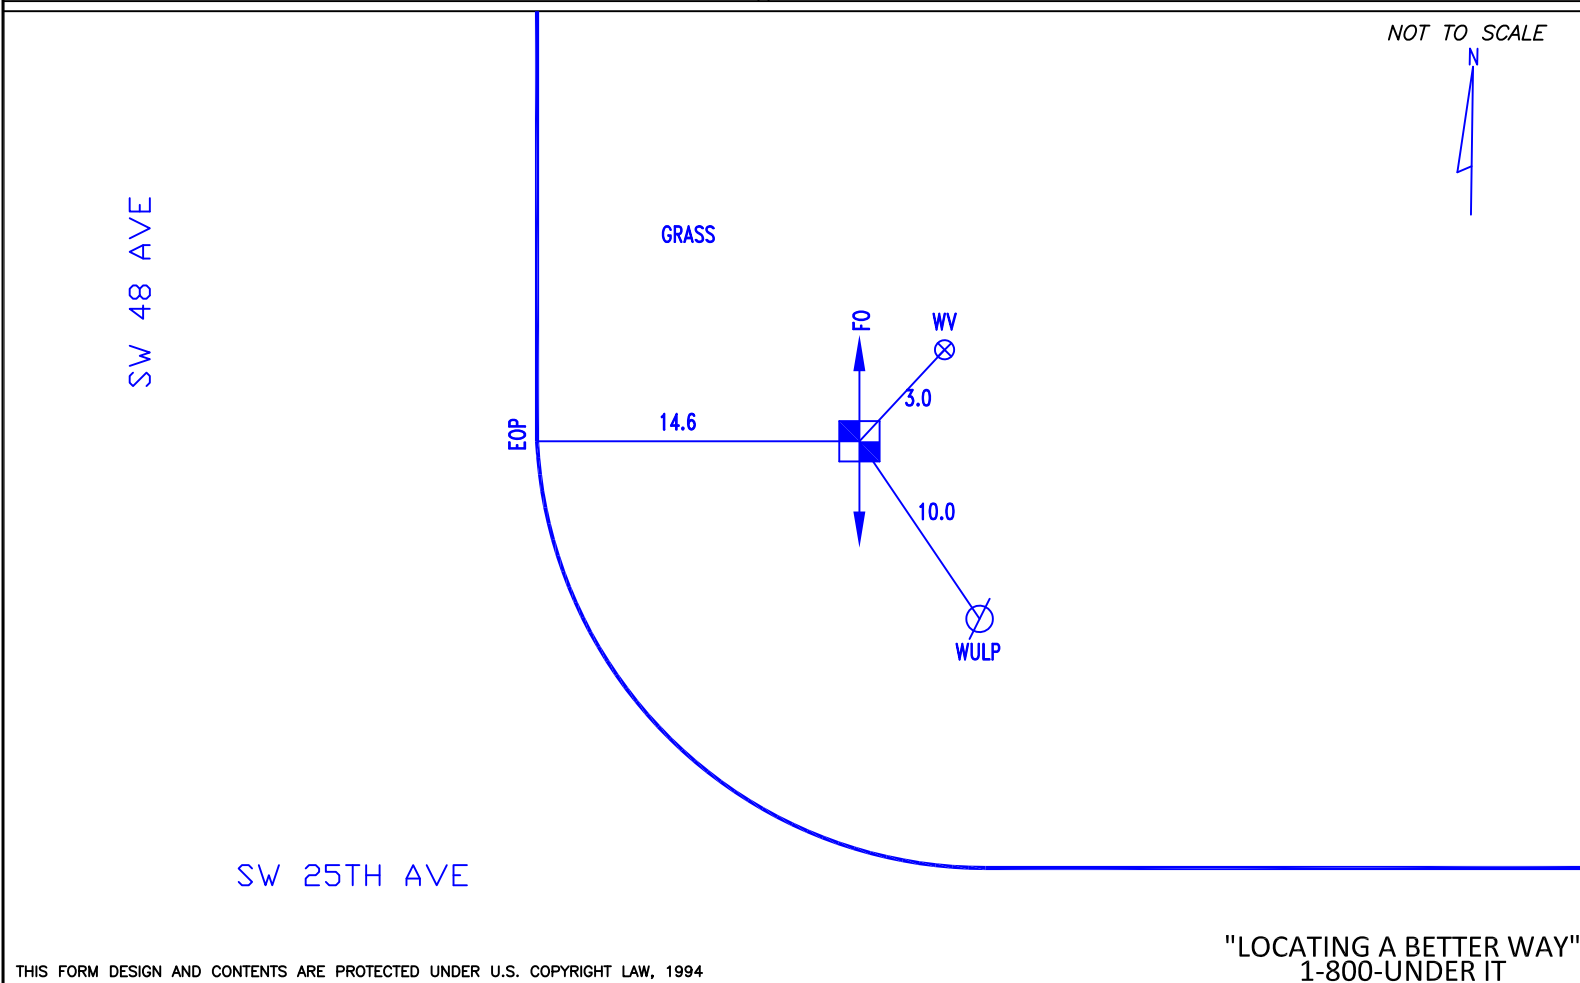
PROJECT NAME:	SW 48TH AVENUE COMPLETE ST - THS
LOCATE REQUESTED BY:	CRAVEN THOMPSON & ASSOCIATES
UTILITY REQUESTED:	FIBER OPTIC
UTILITY FOUND:	FIBER OPTIC
MATERIAL AS FOUND:	SEE NOTE
SIZE AS FOUND:	SEE NOTE

CLIENT JOB#	N/A	WORK ORDER #	N/A		
PROJECT LOCATION: WEST PARK, FL					
SHEET #:	C-21 OF N/A	PROPOSED:	UTILITY WORK		
FORM BY:	MP	ASSISTED BY:	DC	# OF HOLES:	1
PAVING CONDITION:	N/A	DATE DUG:	1-10-23		
SOIL CONDITIONS: HARD DRY SAND ROCKY					
UTILITY CONDITION: SEE NOTE

NOTES: UNABLE TO DETERMINE SIZE AND MATERIAL DUE TO ROCKS AND CAVING POSS. SAME UTILITY FROM TH#1 & TH#2.

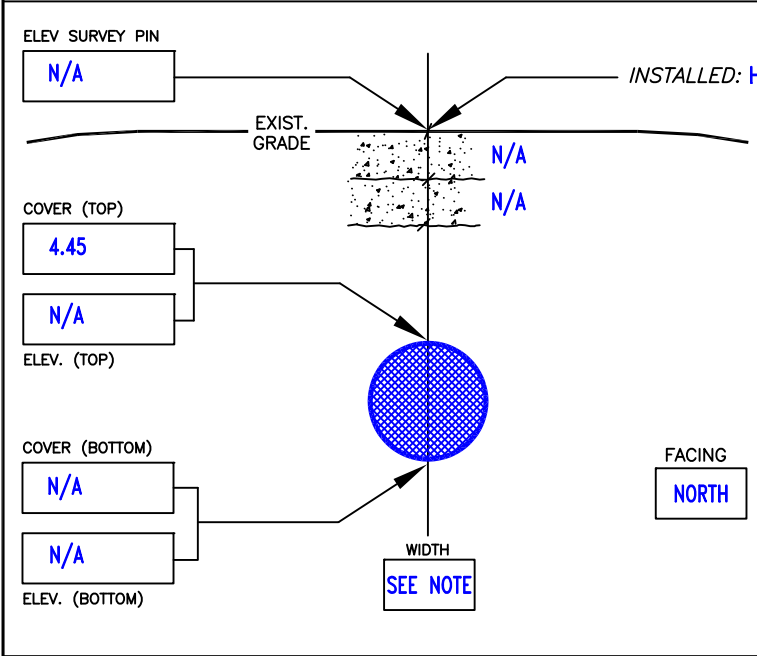
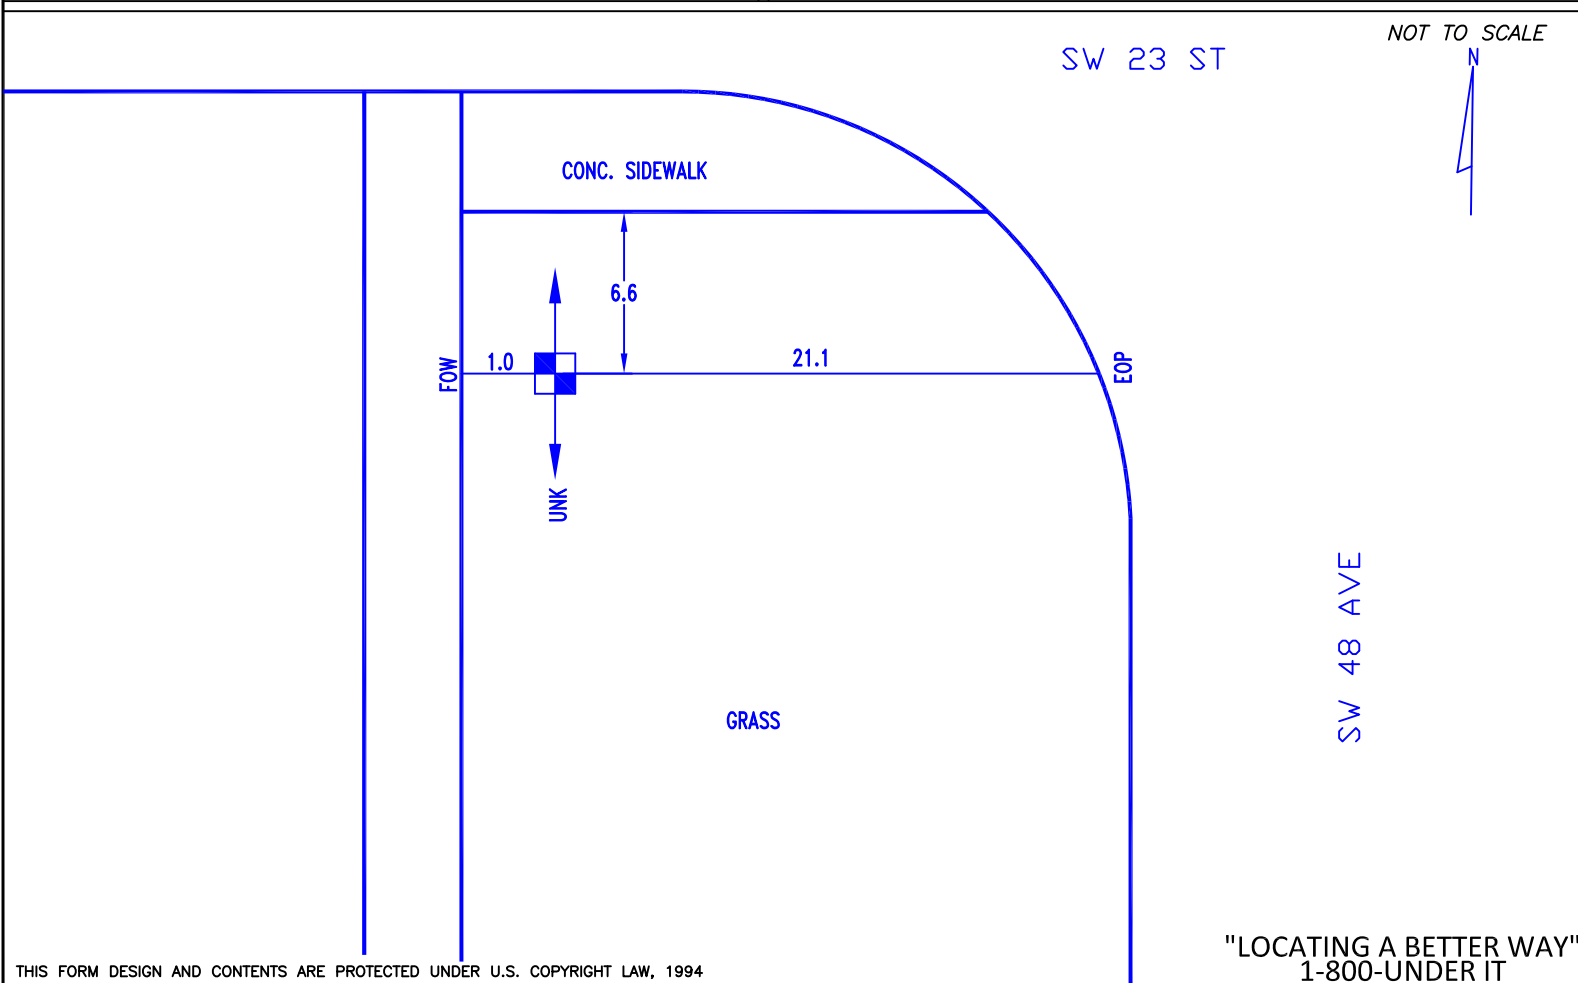
PROJECT NAME: SW 48TH AVENUE COMPLETE ST - THS
LOCATE REQUESTED BY: CRAVEN THOMPSON & ASSOCIATES
UTILITY REQUESTED: UNKNOWN
UTILITY FOUND: UNKNOWN
MATERIAL AS FOUND: SEE NOTE
SIZE AS FOUND: SEE NOTE

CLIENT JOB# N/A	WORK ORDER # N/A
PROJECT LOCATION: WEST PARK, FL	
SHEET #: C-21 OF N/A	PROPOSED: UTILITY WORK
FORM BY: MP	ASSISTED BY: DC # OF HOLES: 1
PAVING CONDITION: N/A	DATE DUG: 1-10-23
SOIL CONDITIONS: HARD WET MOIST SAND ROCKY	
UTILITY CONDITION: SEE NOTE

NOTES: TEST HOLE MOVED 22 FEET NORTH OF REQUESTED DUE TO PARKED CARS. UNABLE TO DETERMINE SIZE AND MATERIAL DUE TO ROCKS AND GROUND WATER.

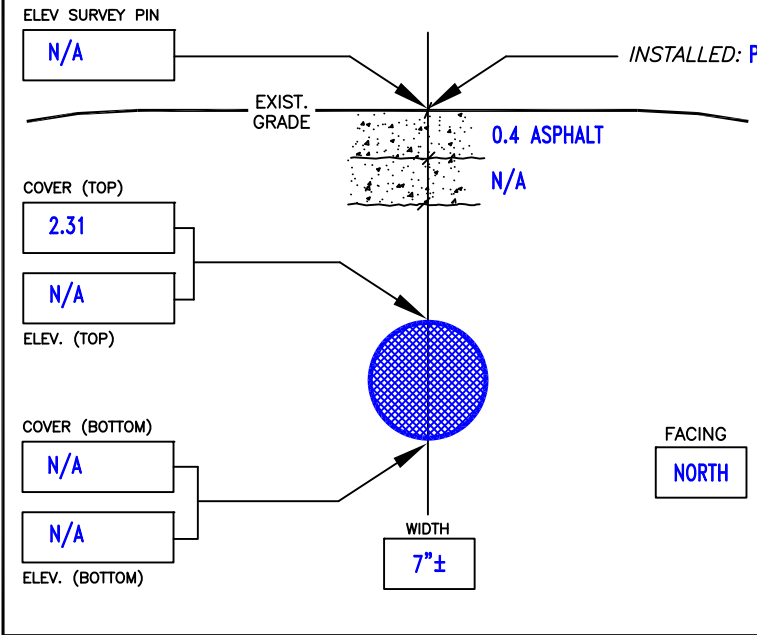
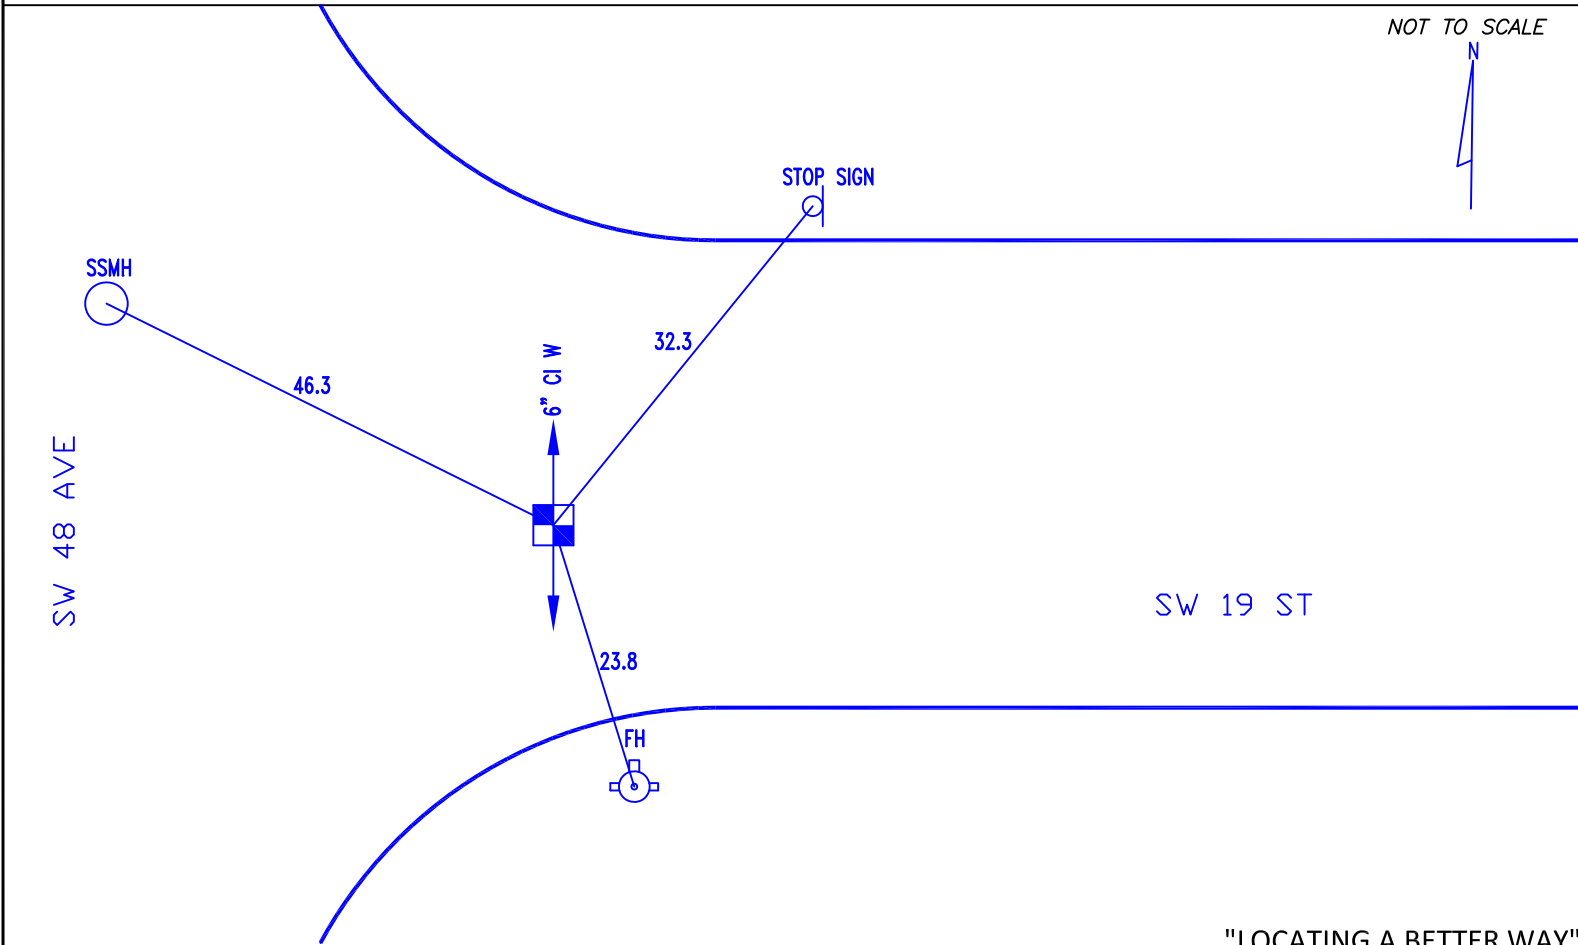
PROJECT NAME:	SW 48TH AVENUE COMPLETE ST - THS
LOCATE REQUESTED BY:	CRAVEN THOMPSON & ASSOCIATES
UTILITY REQUESTED:	8" WATER
UTILITY FOUND:	WATER
MATERIAL AS FOUND:	CAST IRON
SIZE AS FOUND:	6"

CLIENT JOB#	N/A	WORK ORDER #	N/A		
PROJECT LOCATION:	WEST PARK, FL				
SHEET #:	C-21 OF N/A	PROPOSED:	UTILITY WORK		
FORM BY:	MP	ASSISTED BY:	DC	# OF HOLES:	1
PAVING CONDITION:	GOOD	DATE DUG:	1-10-23		
SOIL CONDITIONS:	HARD DRY SAND ROCKY				
UTILITY CONDITION:	GOOD

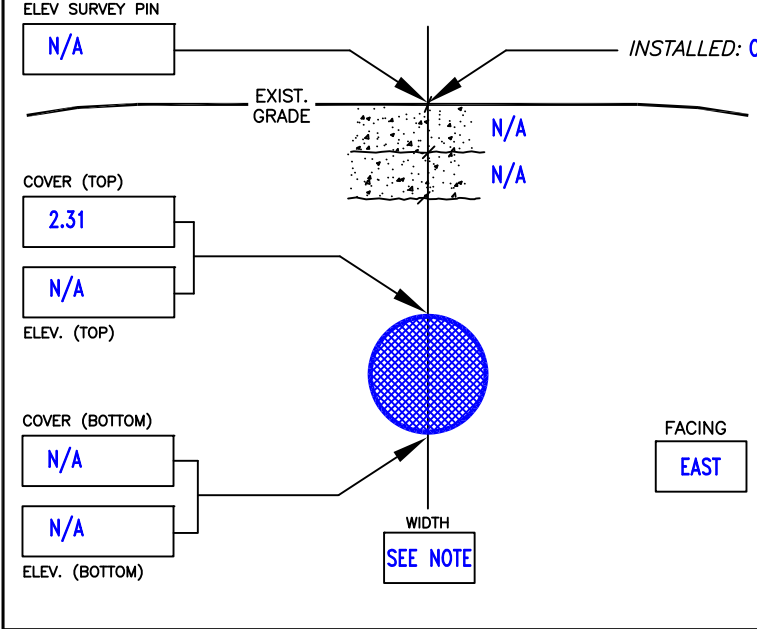
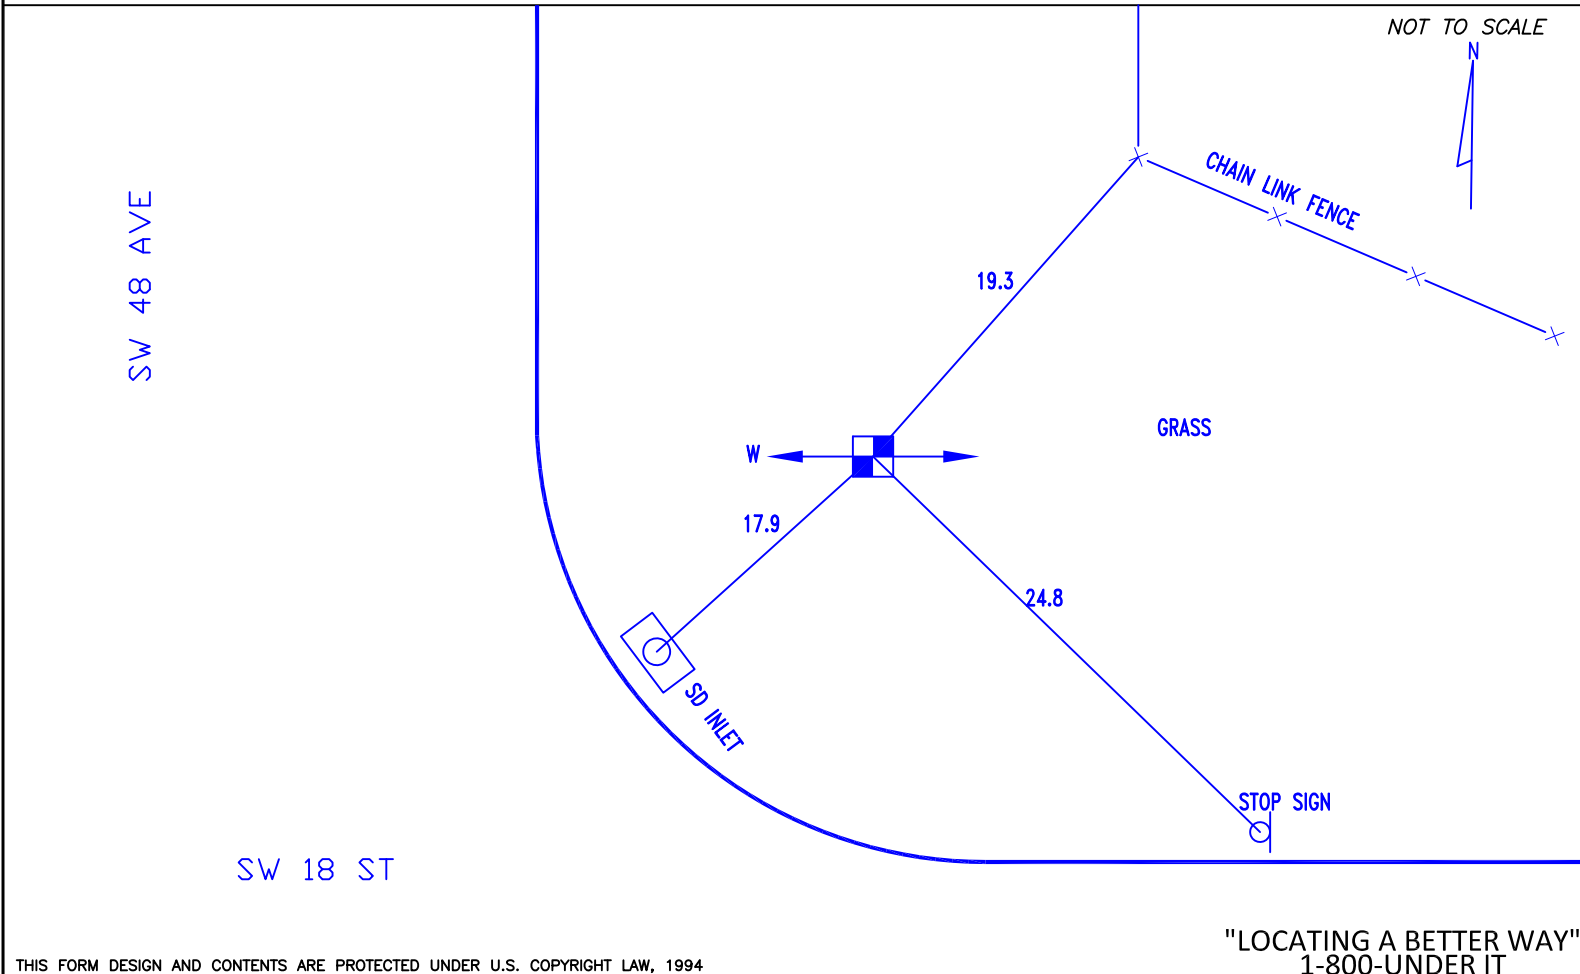
PROJECT NAME:	SW 48TH AVENUE COMPLETE ST - THS
LOCATE REQUESTED BY:	CRAVEN THOMPSON & ASSOCIATES
UTILITY REQUESTED:	WATER
UTILITY FOUND:	WATER
MATERIAL AS FOUND:	SEE NOTE
SIZE AS FOUND:	SEE NOTE

CLIENT JOB#	N/A	WORK ORDER #	N/A		
PROJECT LOCATION:	WEST PARK, FL				
SHEET #:	C-21 OF N/A	PROPOSED:	UTILITY WORK		
FORM BY:	MP	ASSISTED BY:	DC	# OF HOLES:	1
PAVING CONDITION:	N/A	DATE DUG:	1-10-23		
SOIL CONDITIONS:	SOFT WET MOIST SAND				
UTILITY CONDITION:	SEE NOTE

NOTES: UNABLE TO DETERMINE SIZE AND MATERIAL DUE TO GROUND WATER.
